**NBSIR 76-1159**

# Fatigue and Weatherability Studies of Aramid-Fiber Rope Slings

September 1976

U.S. Army Air Mobility Research and Development Laboratory Eustis Directorate
Fort Eustis, Virginia 23604

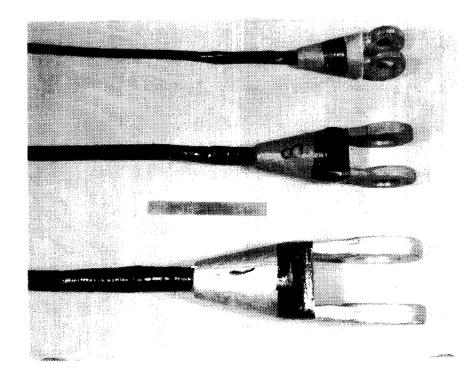
The parallel-strand ropes were all jacketed with black braided nylon that had been treated with neoprene to reduce moisture penetration (Figure 1).

The parallel-strand ropes used commercial, forged-steel, open spelter sockets of the type that is conventionally used for steel wire rope (Figure 1). The tops of the baskets had been built up with tape to provide a longer potting length. Where the ropes entered the sockets, the jackets were reinforced with tape.

Figure 1. Sling-leg specimens in three tensile capacities, fabricated from parallel-strand ropes with neoprene-impregnated, braided nylon jackets and potted, open spelter sockets. (Disregard the numerals on the sockets; they are not specimen designations.)

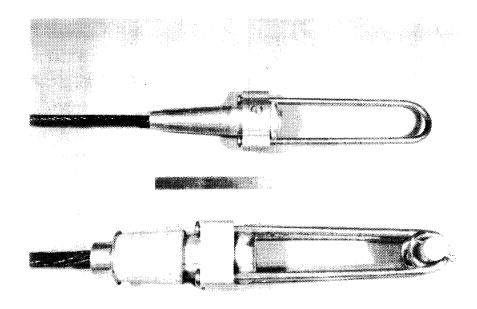
The low-capacity cabled-strand ropes had extruded polyurethane jackets (Figure 2a). One out of three medium-capacity cabled-strand ropes also had an extruded polyurethane jacket (Figure 2b); the other two had thicker, polypropylene jackets (Figure 3). The high-capacity cabled-strand ropes all had white braided polyester jackets (Figure 4).

The low-capacity cabled-strand ropes were fitted with commercial potting heads of a type that is widely used for synthetic-fiber rope (Figure 2a). In the medium size, two cabled-strand ropes were furnished with similar, but larger, potting heads that had been reinforced with conical metal sleeves (Figure 2b); and one cabled-strand rope was fitted with open spelter sockets similar to those used on the parallel-strand ropes. Experimental end fittings were used on the high-capacity cabled-strand ropes. Two of these ropes were furnished with steel fittings of the type shown in Figure 4, bottom, and one had proprietary phosphorbronze fittings such as that illustrated in Figure 5.

Figure 2. Sling-leg specimens in two tensile capacities, fabricated from cabled-strand ropes with extruded polyethylene jackets.

(a), above: low-capacity specimen (No. 3) with potting head.

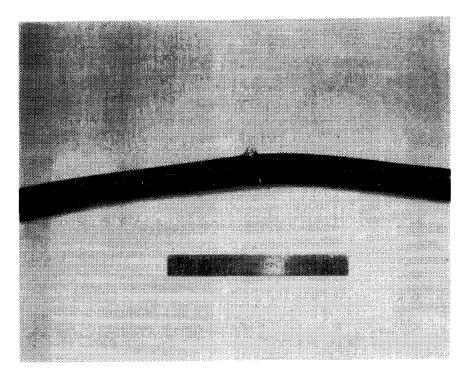
Of the five cabled-strand specimens which were tested, three, representing one of each tensile capacity, survived without failure. A fourth, of medium-capacity, suffered a partial failure (Figure 3), but nevertheless survived the entire test. The fifth, a high-capacity specimen, failed in its free length relatively early in the test (Figure 4a).

One strand failed after approximately 1 400 000 cycles (Fig. 3). Test subsequently terminated without further failure.

The results of the tests are given in Table 9. Of the seven specimens tested, two failed in their free lengths at loads substantially below their rated breaking loads. One of these, Specimen No. 17 (Table 8) had experienced a failure of one of its strands in its fatigue test, and the other, Specimen No. 8 (Table 6), probably sustained shockloading damage in the recoil from the fatigue failure of its end fitting. The other five specimens all failed in or near an end fitting. The breaking loads for four of these specimens closely approached, or exceeded, the respective rated breaking loads. The fifth, Specimen No. 26, a high-capacity cabled-strand specimen, failed at only 78 percent of its rated breaking load. The failure occurred adjacent to both of its end fittings despite the fact that there had been no seepage of potting compound from the fittings. See Figure 4b.

Figure 3. Sling-leg specimen (No. 17) with a rope strand that failed in fatigue and punctured the polypropylene jacket. This is a medium-capacity specimen, fabricated from cabled-strand rope.

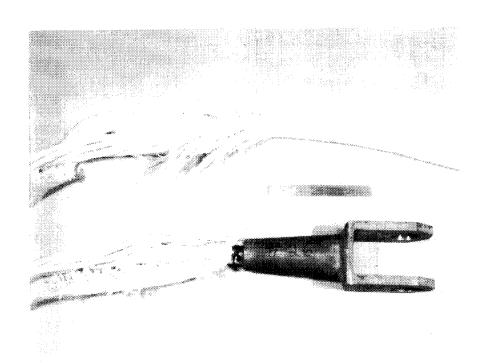
Specimen failed in free length (Fig. 4a). ģ.

specimen, referred to above, which had survived the fatigue spectrum. In its subsequent tensile test, this specimen (No. 26, Table 9) failed at an end fitting at only 78 percent of its rated breaking load.

Figure 4. High-capacity sling-leg specimens after test. These specimens were fabricated from cabled-strand ropes with braided polyester jackets.

(a), above: Specimen No. 25 with free-length failure incurred

(b), below: Specimen No. 26 with failure adjacent to experimental

end fitting, incurred in tension test following

fatigue loading.

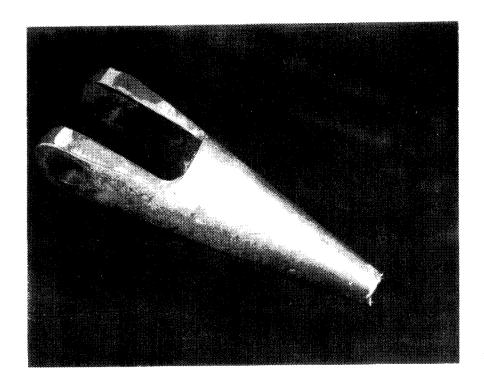
Figure 5. Proprietary, experimental, phosphor-bronze end fitting. Fittings of this kind were used on one high-capacity, cabled-strand, sling-leg specimen (No. 25).

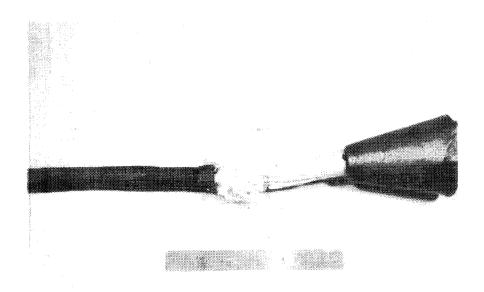
Failed adjacent to end fitting where potting compound had seeped into the free length (cf Fig. 6).

All of the parallel-strand specimens were fitted with potted, open spelter sockets. The failures of all but one of these specimens was clearly attributable to inadequacies related to the fittings. Two such inadequacies were predominant. One was the potting technique, which permitted potting compound to seep into the rope fibers outside of the fitting before it was cured, thereby diminishing the flexibility of the rope near the fittings. The second inadequacy was the potting compound itself. While the potting compound exhibited the flexibility, under normal environmental conditions, that NBS work has shown to be desirable [4], its degradation under the simulated weathering exposures was excessive.

Figure 6. Parallel-strand sling-leg specimen with failure adjacent to an end fitting where the potting compound had seeped into the rope fibers and diminished their flexibility.

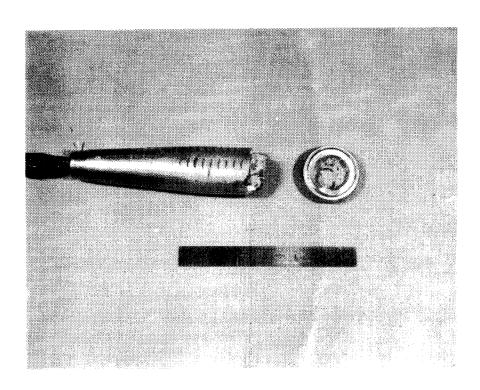
Fracture of lip on potting head of one end fitting (Fig. 7).

The residual strengths, of the seven specimens which had survived the fatigue tests, were measured with tensile tests. These tests were performed in a 400 000-1bf (1.78-MN) capacity, screw-powered testing machine [1] at a crosshead speed of 0.75 in/min (0.32 mm/s). Each specimen was subjected to ten cycles of load, from zero to a predetermined load and back to zero, before the load was increased to failure. For Specimen No. 8, which had previously suffered a fatigue failure of one of its end fittings (Figure 7), the potting head was clamped directly into the tapered wedge grips of the testing machine. The teeth marks seen on the potting head in the figure are the result of this gripping.

Figure 7. Fatigue failure of potting head on Specimen No. 8. This is a low-capacity, cabled-strand, sling-leg specimen which was subsequently tested in tension by gripping the remaining portion of the potting head with wedge grips.

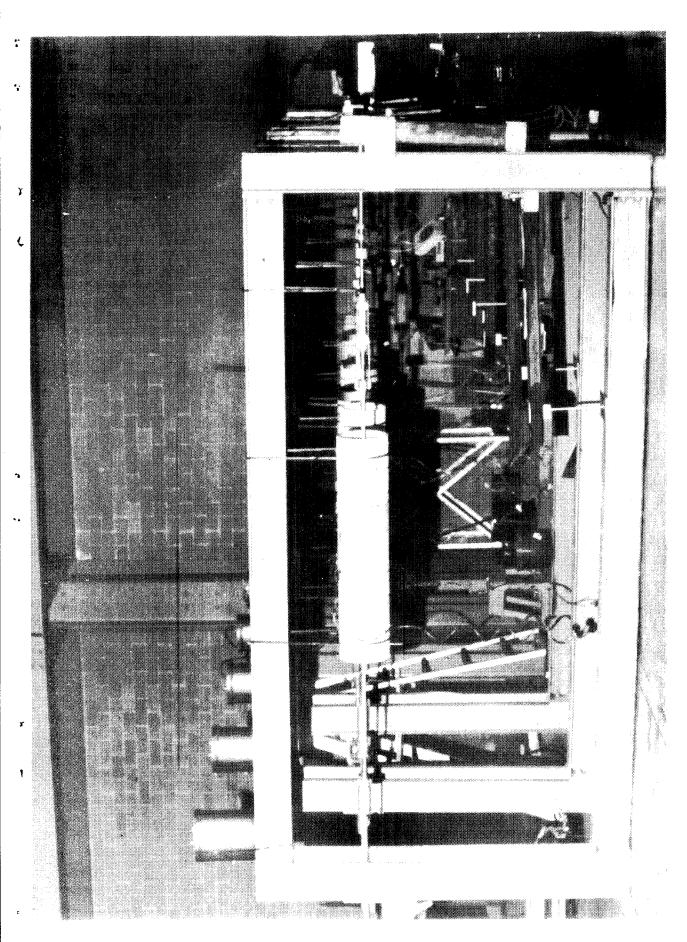
The required tensile loads were applied to the specimens by 30 000-lbf (130-kN) capacity, horizontal, dead-weight, lever-arm, creep-testing machines (Figure 8) which can accommodate tensile specimens up to nine feet (2.7 m) long [3]. The test environments were provided by environmental chambers installed in the machines.

NBS high-capacity creep-testing machines, shown here with environmental chambers installed for simulated weathering tests of pultruded fiberglass rod specimens under tensile load. Figure 8.
